## M1, Deansbrook Viaduct, Scratchwood, Structural Repairs of Fire damage.

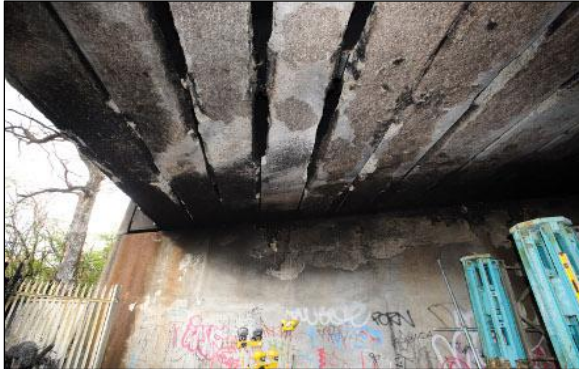
Damage caused by Fire
