Halton Lea Shopping Centre Car Parks, Runcorn

Major refurbishment by principal contractor Balvac of four shopping centre car parks gains owner prestigious Secured Car Parks award.

Client	Fordgate Midlands Properties
Project Manager	Citex Bucknall Austin
Consultant	Modus Consulting Engineers
Principal Contractor	Balvac
Value	£2.9 million

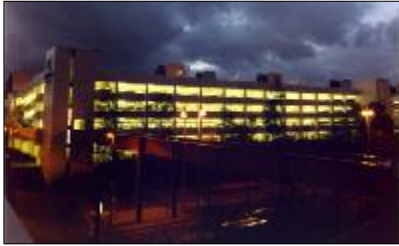
Four car parks serve the shopping centre

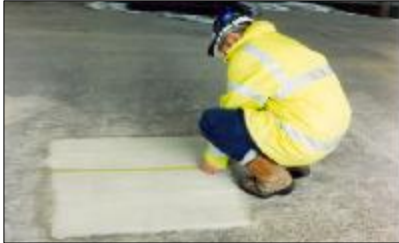
Major concrete repairs were needed

Works processes included: extensive concrete repairs to deck slabs, design and installation of a cathodic protection system, a BBA backed deck waterproofing system with 10 year warranty to the upper decks of all four car parks, inter-deck coatings and line markings, design and installation of a full new lighting system throughout, cleaning, repair and coating of all concrete surfaces, establishment of disabled and parent/toddler safe zones, new pedestrian and motorist signage throughout, and extensive re-bonding and replacement of missing tiles to the external facades.

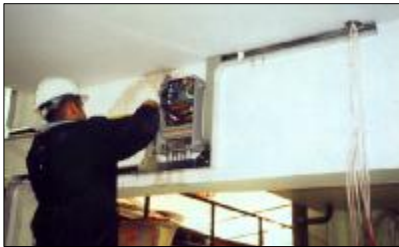
Cathodic protection was installed

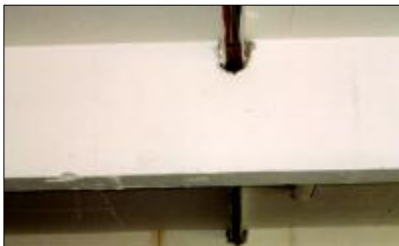
..... and the lighting replaced and upgraded

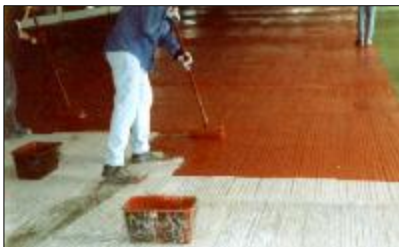
All decks were waterproofed

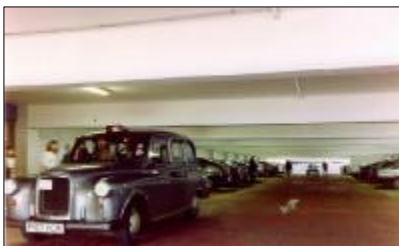
..... and all other surfaces coated
