## Leeds Tower Blocks, Phase 2

Client negotiates follow on contract to repair and refurbish four further residential tower blocks to a high standard with minimum tenant disruption.

Client	Leeds City Council
Principal Contractor	Balvac
Contract Value	Approx £ 2.2m
Programme	35 weeks
Completion	March 2003

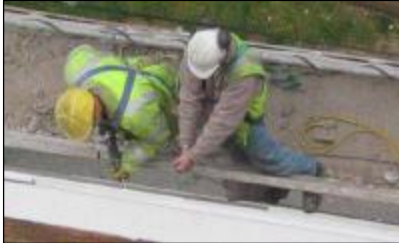
Most work was carried out from cradles

Work commenced with the roofing package. The existing roofing was removed and replaced with a high performance mastic asphalt system. The air extraction plant serving the residents bathrooms was also replaced with new. Roofing works were serviced using an Alimak type hoist on each building. Once complete access cradles were suspended from the roofs allowing work on the building elevations to start.

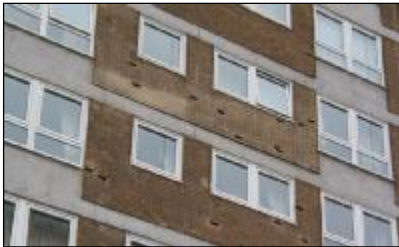
Repointing and brick replacement

After an initial survey, perished and damaged bricks were removed and replaced, and areas of failed bedding mortar removed and re-pointed. Many of the original brick ties were found on inspection to be spaced too far apart and beginning to corrode – significant numbers of replacement ties were installed using drilled fixings. Concrete repair work was focussed in particular on the roof parapets and floor slab edges, defective concrete was replaced with a repair mortar, and then a decorative finish applied throughout.

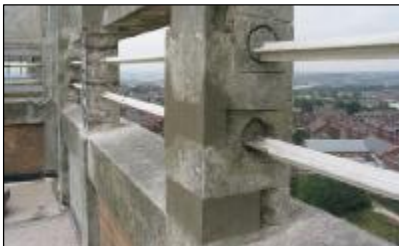
Concrete repair to roof parapets

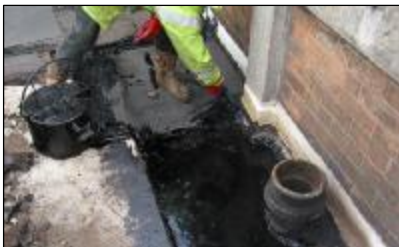
Re-roofing with high spec mastic asphalt

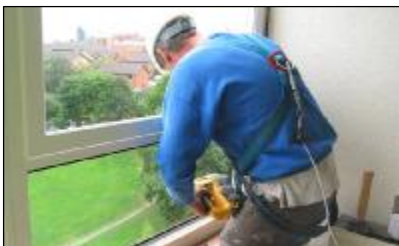
One block required window replacement

Replacement UPVC windows were fitted in one of the four tower blocks, significantly increasing tenant's comfort. Tenant liaison and attention to tidiness was an important aspect of this part of the contract when access through flats was required.
