M4 Winnersh Interchange

Major Interchange Refurbishment

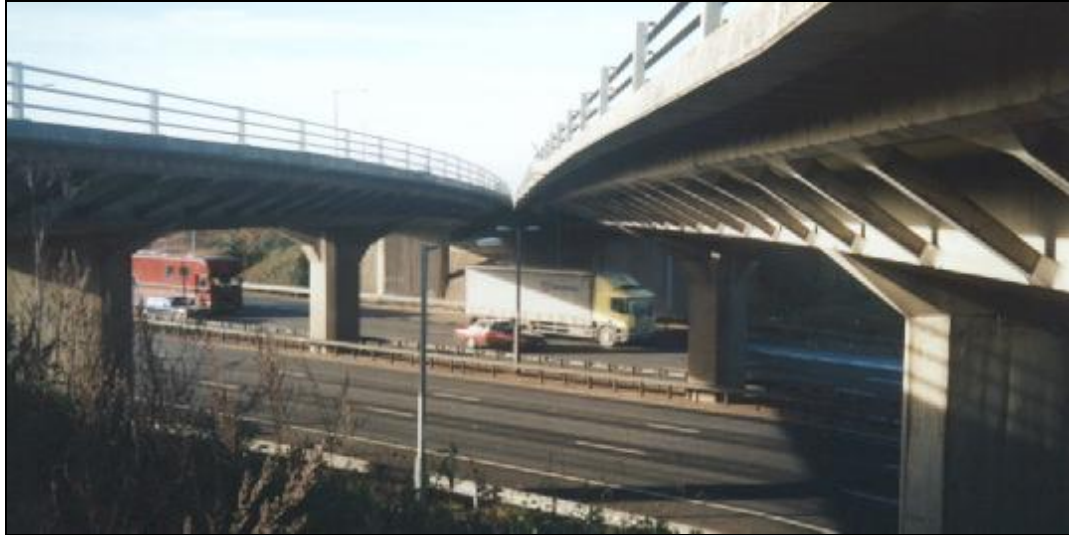
The distinctive bridge design is repeated in a number of structures along the M4
