Mell Square Multi-Storey Car Park, Solihull

Careful planning and teamwork keeps busy town centre multi-storey car park open to traffic during major structural repair contracts.

Client	Solihull MBC
Principal Contractor	Balvac
Value	Phase 1 £ 230,000, Phase 2 £ 130,000
Programme	Phase 1 Oct 02, Phase 2 Mar 04

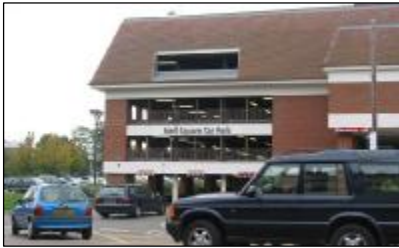
The car park remained open during repair

Balvac was awarded two separate repair contracts by client and designer Solihull MBC. For these first phases of an ongoing programme of repairs Solihull decided to concentrate on slab repairs, being structurally the most serious defect, as well as a tripping hazard and unsightly. Some coatings were also applied. It was a contract requirement that the car park remained operational throughout, with spaces returned to use wherever possible on Saturdays.

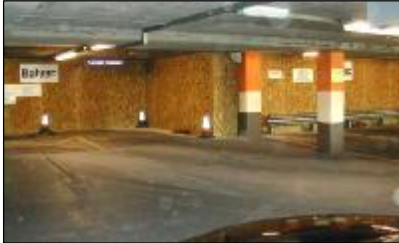
Traffic was protected from repair activity

Hydro-demolition was chosen to remove defective concrete in preference to hand break out during the second contract. Works areas were secured and separated from traffic using temporary timber panels running from floor to ceiling. These panels protected adjacent traffic from dust, spray and debris and importantly also served to mitigate noise nuisance both within the car park and at nearby business premises.

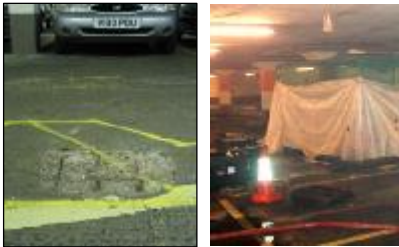
Spalling was removed by hydro-demolition

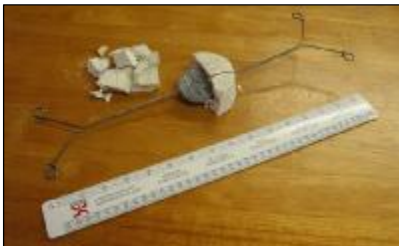
Galvashield XP anodes were used

Areas were repaired using Patchroc GP repair mortar made by Fosroc. This is a fast setting mortar, repaired areas can be trafficked within three hours of placing. The mortar was used neat for areas up to 4 m² but bulked out using pea gravel for larger areas or patches more than 100 mm deep. The lifetime of the repairs was prolonged through incorporation of Fosroc Galvashield XP sacrificial anodes into each patch. These units are quick and easy to install, and deliver a highly cost effective and durable repair.

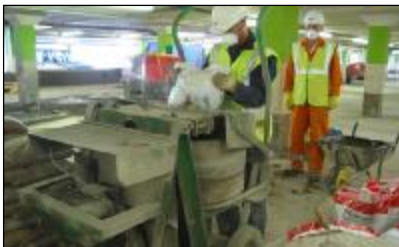
Mixing of repair mortar

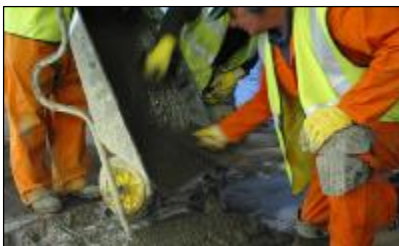
Placing of repair mortar
