St. Sophia's, Galston – Major Restoration of Historic Church

Repair techniques, both old and new, have role to play in major restoration of listed church building.

Client	Diocese of Galloway
Principal Contractor	Balvac
Duration	14 months
Completion	March 2004
Value	£ 1.2 m

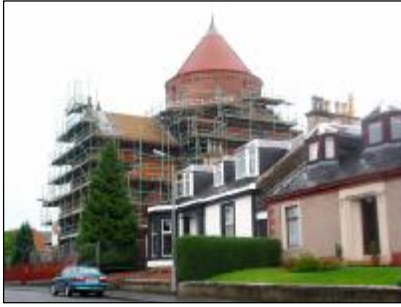
The church dominates Galston

The roofs were strengthened and re-tiled

Externally the 30 metre high dome and other roof areas were renewed with 1000s of individually cut roof tiles. Brickwork repairs were also carried out where the original had perished or been damaged. All the new tiles and bricks were faithful copies of the originals in terms of style, colour and texture.

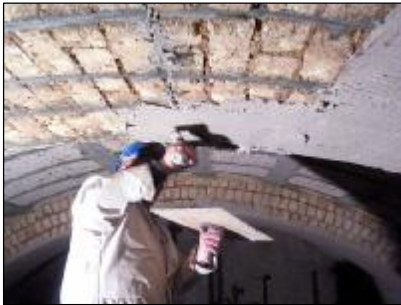
Lime plaster was chosen for authenticity

Internally the vaulted roofs, an early example of reinforced concrete, were strengthened using the Helibar system, then the original reinforcing bars protected from further corrosion using sacrificial anodes. The majority of the plasterwork had failed, this was removed and replaced with traditional lime plaster, chosen for its durability and to be in keeping with the original. The plaster, after an extensive curing period, was coated with a compatible lime based paint.
