## Moor Street Car Park, Birmingham Bullring

Grade II listed warehouse featuring early Hennebique reinforced concrete design restored and incorporated into modern shopping centre car park.

Client	Birmingham Alliance
Principal Contractor	O'Rourke
Repair Specialist	Balvac
Sub-Contract Value	£ 680,000
Completion	Summer 2003

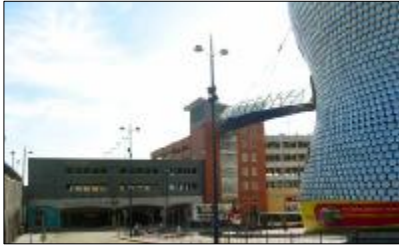
The car park links to Selfridges by bridge

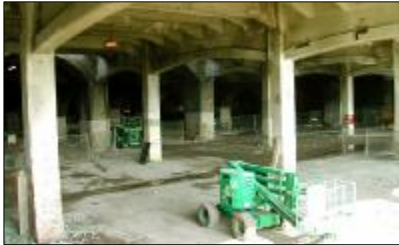
The warehouse was in a decrepit condition

Balvac played a major role in restoring the building, it was in an extremely poor condition after years of neglect and the concrete was suffering from high levels of carbonation penetration. Significant areas of hollow, damaged and spalled concrete were removed by hydrodemolition and replaced with both sprayed concrete and hand applied repair mortars. Surface applied corrosion inhibitors were used to provide additional protection to areas not requiring concrete repair. Finally the entire structure was treated with an anti-carbonation coating to provide a durable and aesthetically pleasing finish.

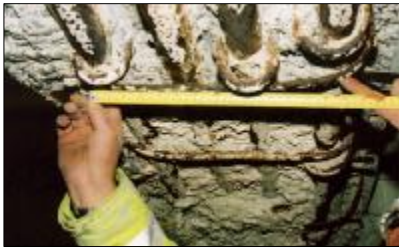
Hennebique designed beam reinforcement

Developers, The Birmingham Alliance, went to great lengths to retain and restore the old building. This was because the warehouse is an early example of design by French engineer, François Hennebique – one of the pioneers of reinforced concrete construction. The structure enjoys a Grade II listing as a consequence.

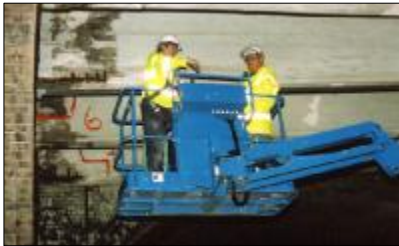
Access platforms were used frequently

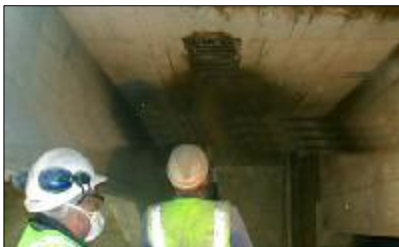
Repairs were made with sprayed concrete

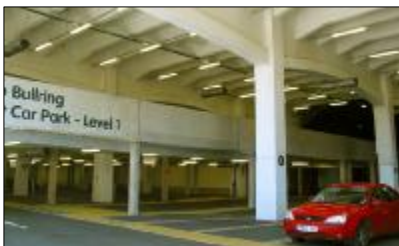
The new car park is light and airy
