Post Tensioning Renewal To Four Reservoirs, Northern Ireland

Post tensioning to live reservoir tanks successfully renewed in operation requiring strictly controlled working methods to ensure safety.

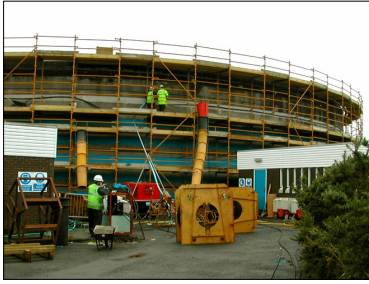
Four tanks were renewed at the Conlig site

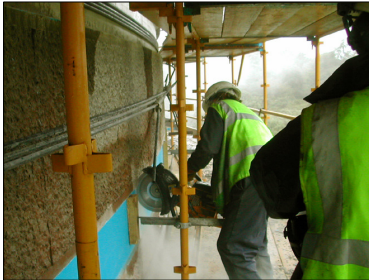
Strand cutting was carefully controlled

Developing a system of de-tensioning that was both safe and controlled was of paramount importance. Balvac's method used restraints fixed to the scaffold access bearing against the existing wire band at regular intervals. The old wires were progressively cut at selected positions until the pre-stress was sufficiently lost for the sprayed concrete and the wires to be broken out safely. The resulting recess was made smooth and the new tendons placed in one or more layers then stressed. The new strands have three layers of corrosion protection, the factory applied grease and plastic coating, followed by site applied spray concrete once installation was complete.

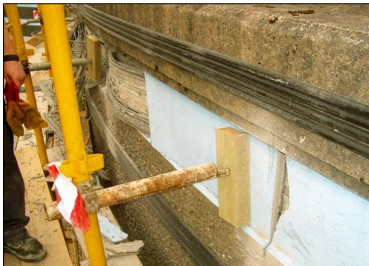
The live tanks needed temporary tendons

In May 2004 Balvac were awarded the subcontract to renew the post tensioning system at four service reservoirs at Conlig, near Bangor, Northern Ireland. The reservoirs were originally built with bands of post tensioning wires protected by sprayed concrete. In some locations the wires had become badly corroded. The scheme developed by Hyder comprised de-tensioning and removing the existing wires and then replacing them with 15.7 mm diameter plastic coated strands, stressed with Balvac MK4 MUT type anchors. The new strands bear directly on the wall with the wire free to move within the low friction coating during stressing. Depending on the tank water level, it was sometimes necessary to install extra temporary tendons to sustain ring tension during the replacement process.

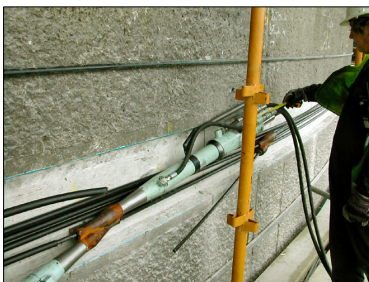
Checking jack extension during stressing

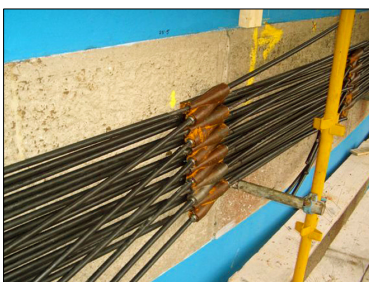
A completed band of tendons
