Post Tensioning – Filter Bed Strengthening, Flint WwTW

Innovative Post Tensioning Solutions...

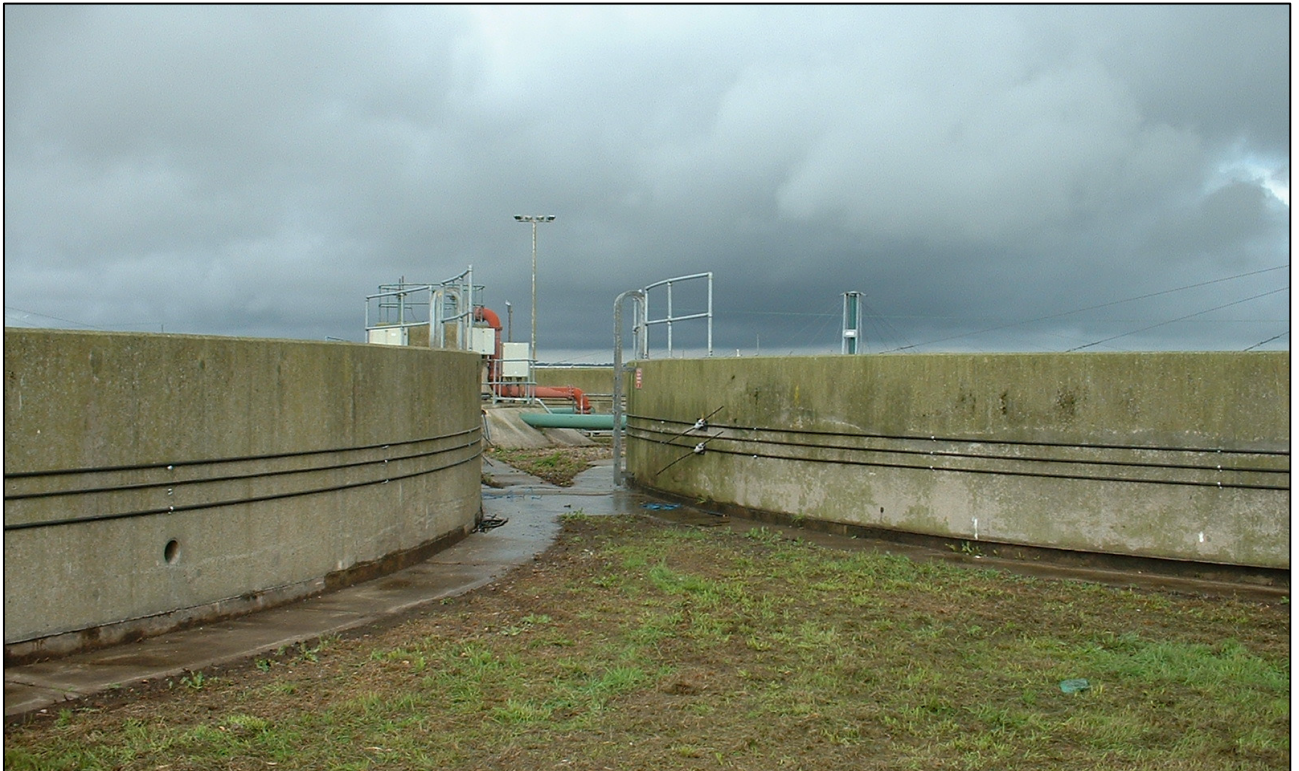
Balvac was awarded the contract to design, supply and install a post tensioning system to stabilise 4 waste water filter beds for client United Utilities. The 2m high and 35m in diameter filters, had suffered varying amounts of corrosion of the rebar.

The structures reinforced concrete walls were affected by corrosion to the rebar at the joints. Corrosion can result in movement of the wall at the joint and, eventually lead to failure of the wall.

The method adopted required post-tensioned tendons to be stressed around the wall circumference in a similar process to the staves of a barrel. The force in the tendons provides resistance against further movement of the wall.

The tendons were placed around the wall on temporary supports and then stressed. The tendons used were 15.7 mm plastic coated strands, anchored in MK4 MUT anchorages, each tendon passing around the full circumference to be placed in the

same anchorage. Stressing was carried out using MK4 stressing jacks to the forces required by our designers. Balvac Consultancy at Croydon carried out the design calculations and completed the drawings.
