Matalan – Distribution Centre Floor Refurbishment

Extensive range of flooring repair techniques ensures major retail distribution centre in good condition and ready for Christmas rush.

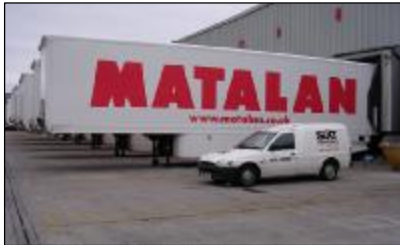
The busy distribution centre operates 24/7

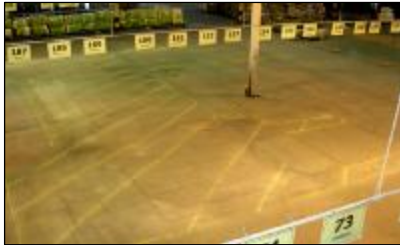
Failed concrete was identified & replaced

A small team on site, worked locally and systematically in phases to break out and replace defective concrete, inject cracks with epoxy resin, and re-form and replace construction and expansion joints. Following each phase of repair work, the warehouse floor was completely re-coated with an industrial floor paint system, colour coded to suit revised storage and distribution activities, and to redefine walkway and access areas.

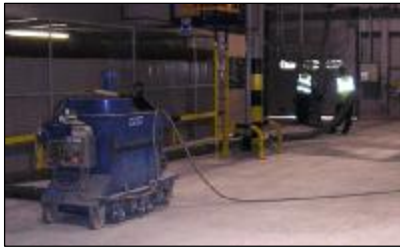
Grit blasting the floor slabs

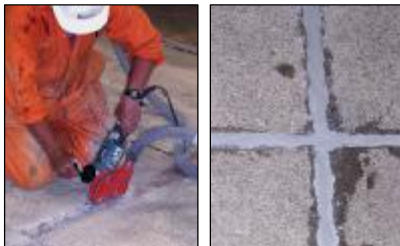
Joints repaired and sealed

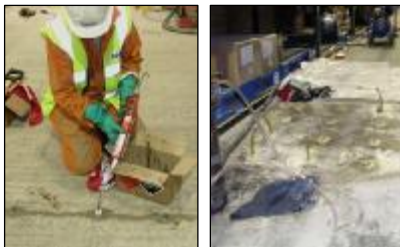
Cracks and voids resin injected

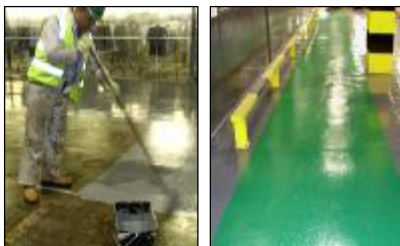
The floor was re-coated after repair
