## SDK/37 Thornton Viaduct, Bradford - Brickwork Repairs

### Brickwork Repairs

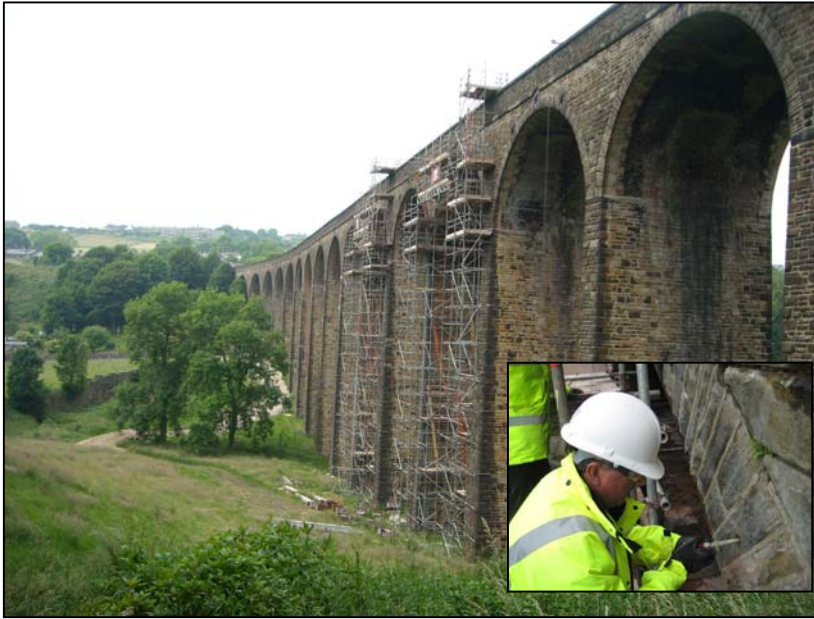
General view of Thornton Viaduct (inset - grouting works)

- Brickwork replacement within the arch barrels.
- Remortatring of the brickwork and masonry.
- Installation of cintec anchors to stitch masonry voussiors to the brick arch barrels.
- Stitching and Grouting of areas of voided brickwork.
- Installation of stainless steel pins to tie in area of replacement brickwork.

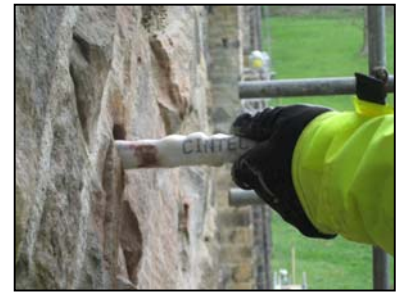
Installation of Cintec Anchors

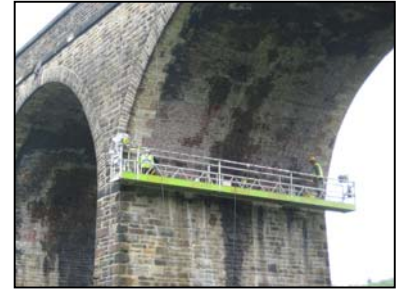
Brickwork repairs from cradle access

To undertake the works to the arch barrel a combination of scaffold and suspended cradles were used to provide access. An early inspection was carried out using a lorry mounted under bridge inspection unit.
