## Sorne Hill Windfarm, Donegal, Ireland

### Balvac successfully repair six wind turbine foundations in Donegal, Ireland.

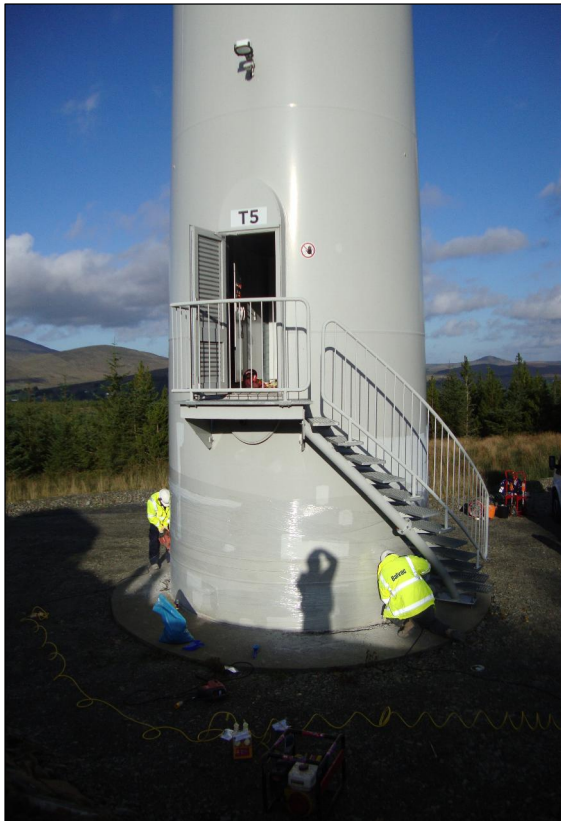
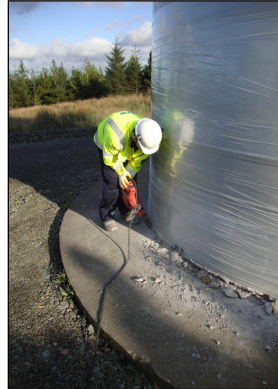
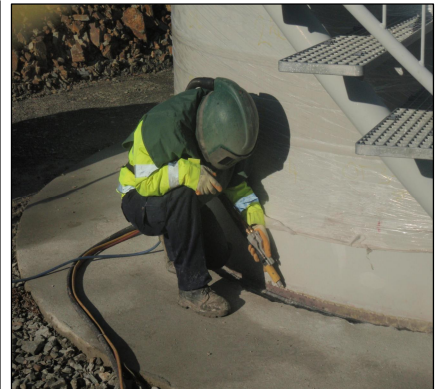
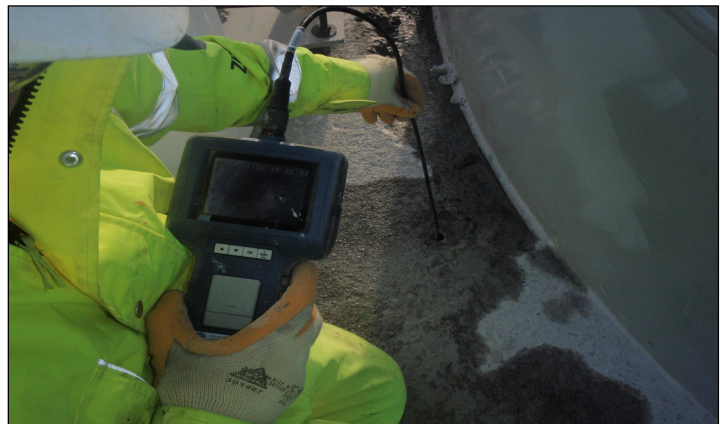
Balvac operatives undertaking specialist repairs, breakout, drilling, inspection, injection and repair

Six number turbines were identified to have excessive movement of the "imbedded can".

- Careful breakout of any delaminated concrete around the base of the turbine.
- Precise drilling to depths in excess of one meter to reach the flange of the imbedded can, inside and outside of the turbine.
- Careful injection using low viscosity water compatible epoxy resin
- Concrete repairs

- Careful preparation and re sealing around the "Can" and foundation interface.
