Ballybane Windfarm, West Cork, Ireland

Balvac utilises its specialist Capability to repair wind turbine foundations in Ireland

Balvac utilising its experience and knowledge repaired four wind farm foundations for a major European Wind turbine manufacturer in West Cork, Ireland.

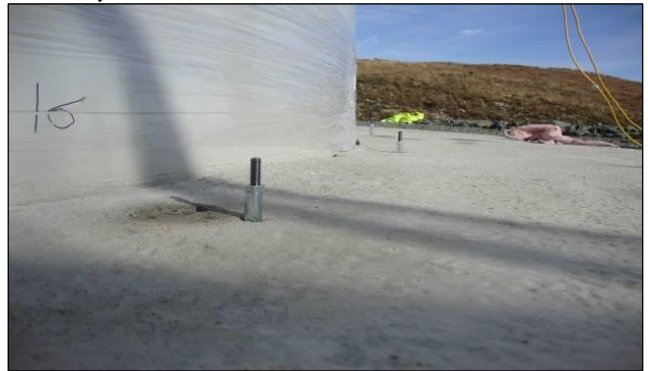
Photo Top : Injection packers in position

- Careful Injection of specialist epoxy resin around the base flange of the can and between the can and concrete both outside and inside the Tower
- Removal of excess resin and the surface preparation of concrete / reinforcements
- Application of corrosion inhibitors and concrete repair mortars
- Preparation and careful application of specialist sealants around the “Can”

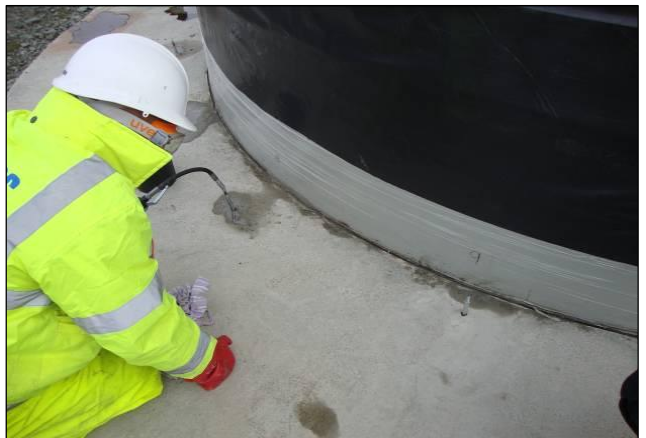
Photo Bottom Injection in progress
