Wylfa Power Station, LC28 Strengthening of Blockwork

Cracked blockwork walls in operational nuclear power station repaired and secured against future movement using thin diameter stainless steel rebar set into coursing.

Client	BNFL Magnox
Principal Contractor	Balvac
Contract Value	£170,000
Programme	3 phases of 5 weeks
Completion	May 2004

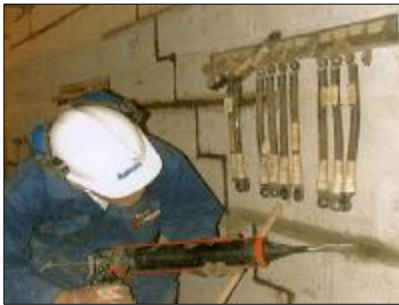
Gun applying the bedding mortar

The mortar bedding either side of a crack was removed to a depth of 35 mm using a twin blade diamond tipped wall chaser. The chaser was fitted with vacuum extraction equipment to contain dust in the sensitive plant and battery rooms bounded by the blockwork walls. A modified cementitious bedding mortar was then gun applied to the back of the chase, the 6 mm diameter Helibar laid into the mortar, then covered over with a 2nd layer. The chase was finally pointed up with Thoro Dry Joint and the repaired areas repainted to match existing. In total over 1,000 m of Helibar was installed, typically using a 1.2 m length across a crack on every other block course.

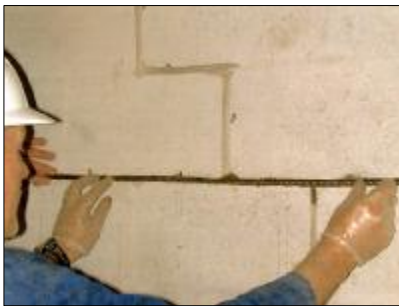
Laying in the stainless steel Helibar

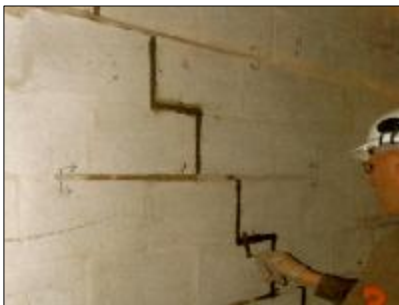
Pointing up the repair

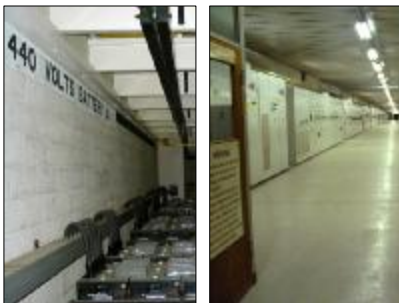
Plant rooms required careful dust control
